Report on Inspection on KANGRIM Aux. Boilers And Economizers

Subject LNG SOYO	Page 1/22
Customer TEEKAY SHIPPING LIMITED	Issued by Kaswadi Hussein
Place of Inspection ANCHORAGE, SINGAPORE	Date of Inspection 01/12/2013

IMC FZC Hamriyah – Sharjah, was requested to attend the vessel “LNG SOYO” which was in, Western Anchorage, Singapore with a view to carry out inspection of the vessel’s Kangrim Aux boiler of 2 Nos. and Kangrim Exhaust Gas Economizers of 4 Nos. The inspection was needed to determine the condition of the existing boiler and exhaust gas system.

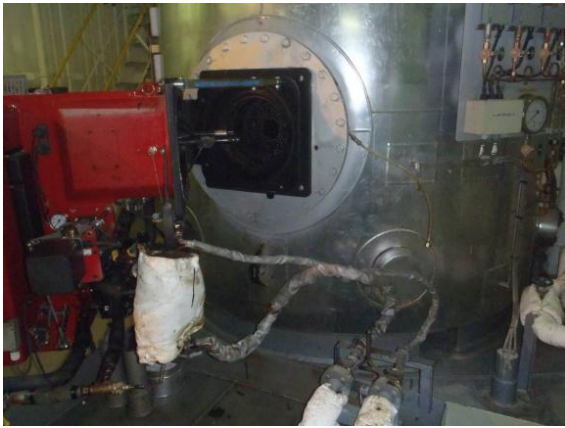
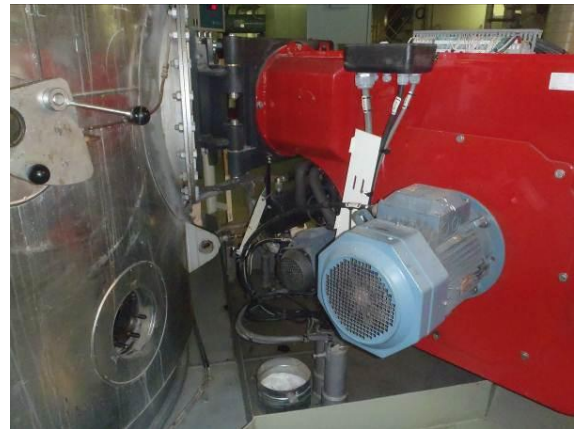
Pic no. 1 & 2: Burner opened for entrance. Area around the burner and full system appear to be in good clean condition.

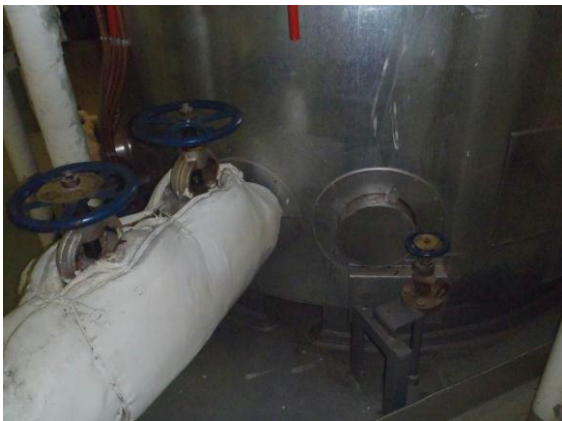
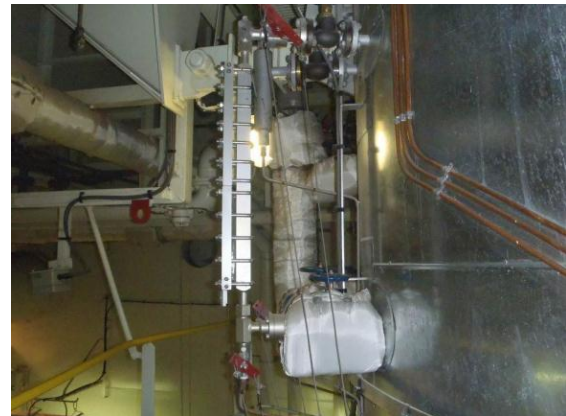
Pic no. 3 & 4: Valves in pillows, hand hole cladding, Water level gauge glasses and mountings still in acceptable condition.

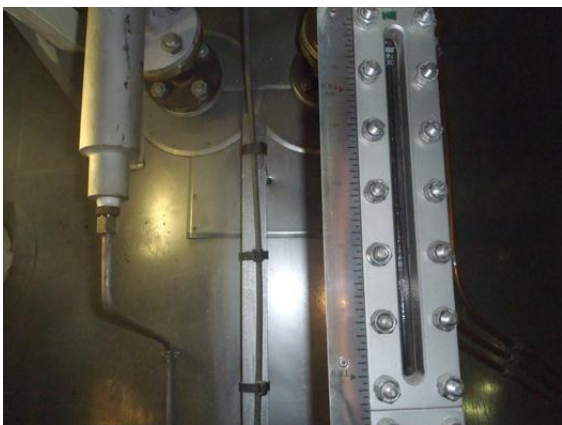
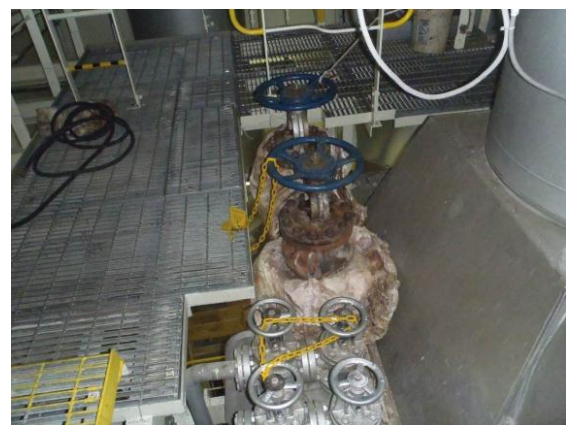
Pic 5 & 6 : Gauge glass found to be good condition with water visible and no signs of crack, mounting on top of boiler found to be in good condition.

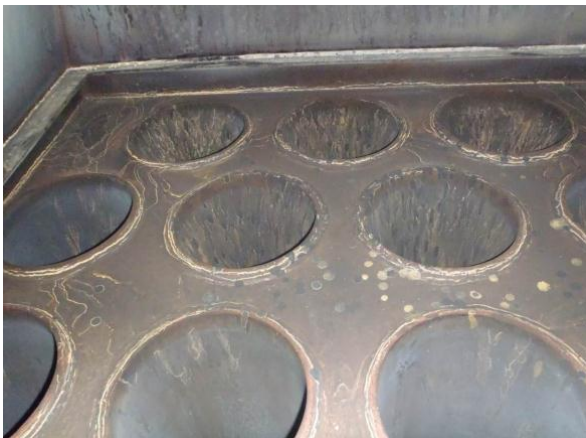
Pic 9: Tubes in gas uptake side in good condition

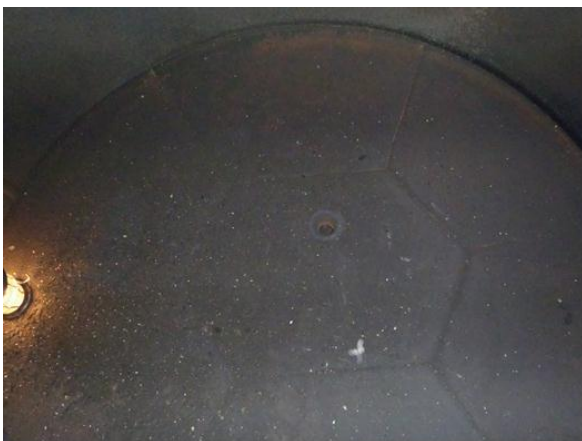
Pic 11: Furnace floor refractory still intact with drain plug

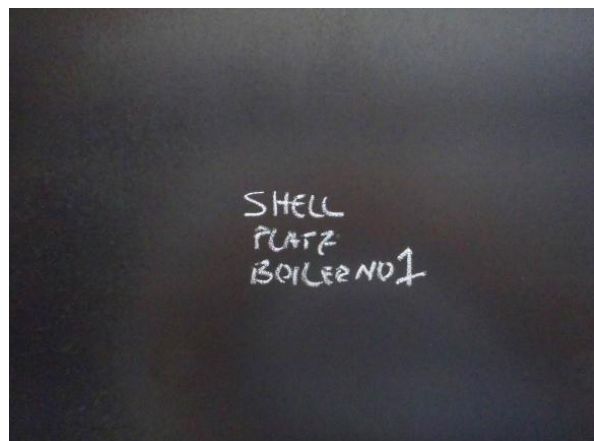
Pic 12: Shell plate was found with no distortion/buckle

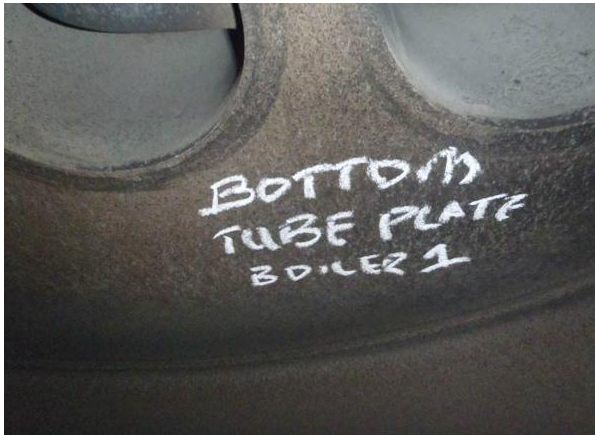
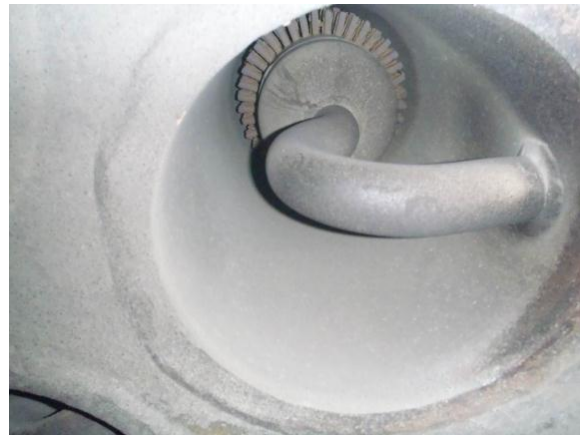
Pic 13 & 14: Bottom tube plate found without distortion and lower elbow of the pin element-weld connection has no visible crack

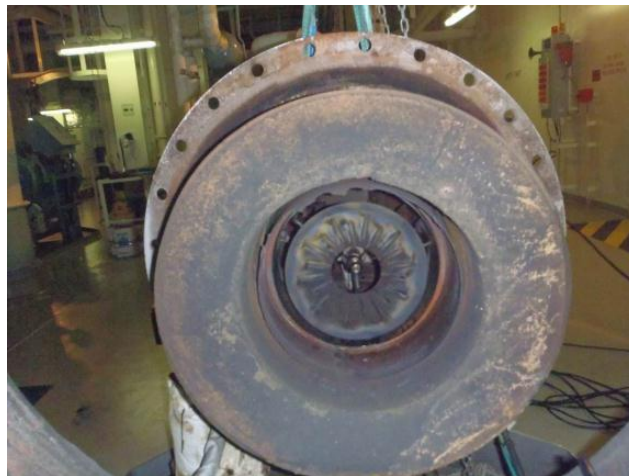
Pic 15: Burner assembly-diffuser plate, vanes, nozzle found in sound condition, the refractory as well is good.

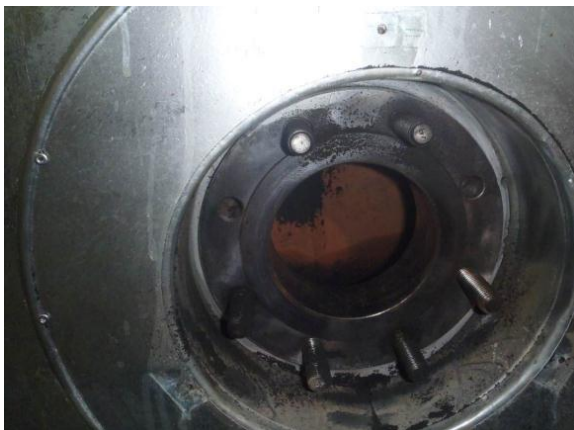
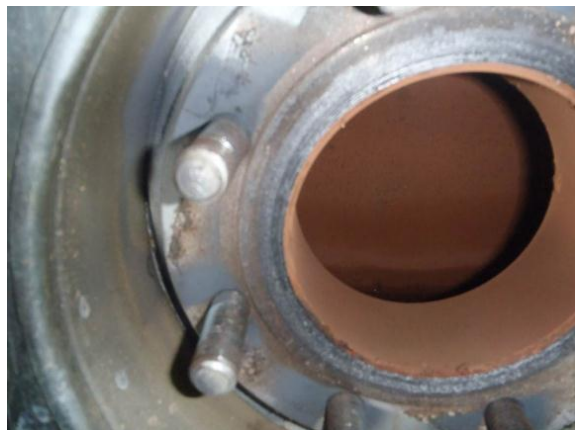
Pic no 16 & 17: Hand-hole No.01 & 3 seating in acceptable condition with small amounts of soot deposits noticed

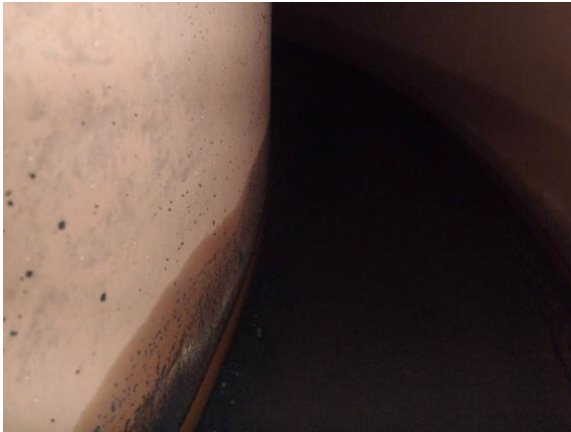
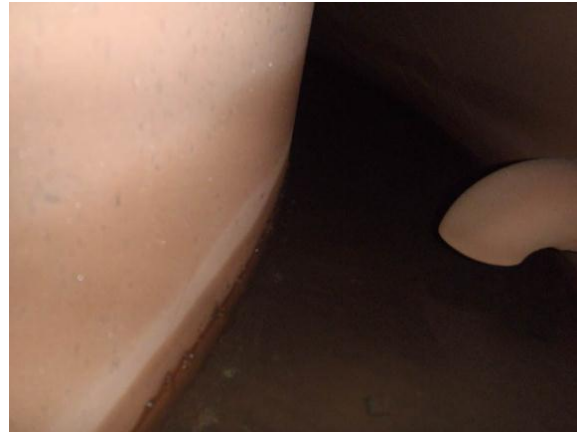
Pic no 18 & 19: Showing the bottom ring plate & furnace shell water side seen from hand hole No.1 & 3 respectively. No internal corrosion and negligible loose debris at the bottom

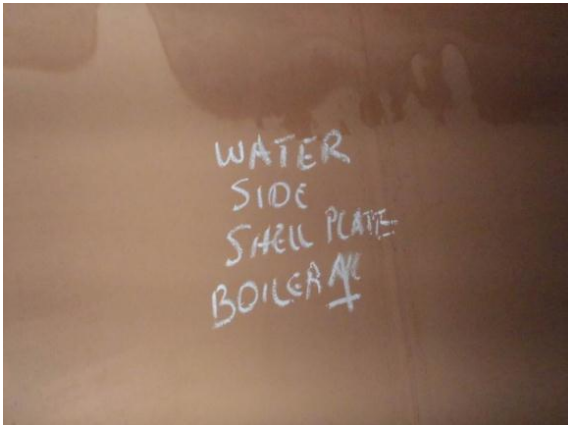
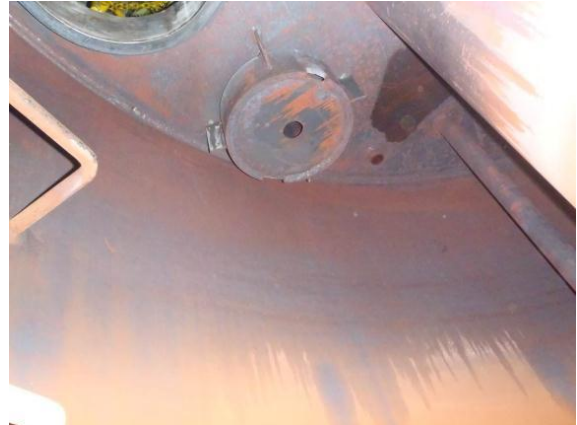
Pic no 20 & 21: Water side shell, top tube plate (Steam space) penetration piping were observed with no visible defects.

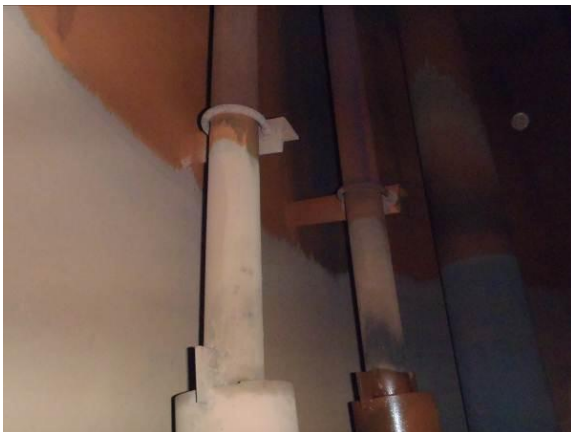
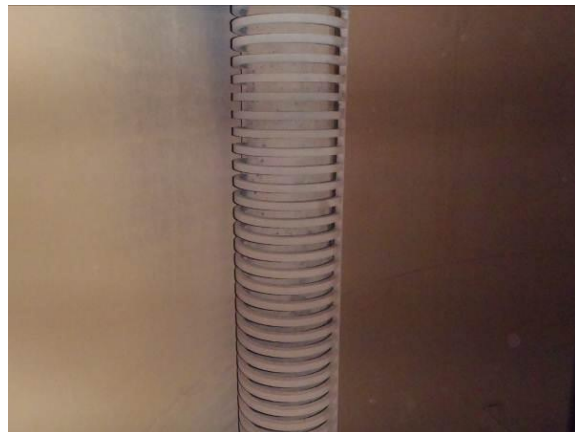
Pic no 22 & 23: All boiler internals are in good condition

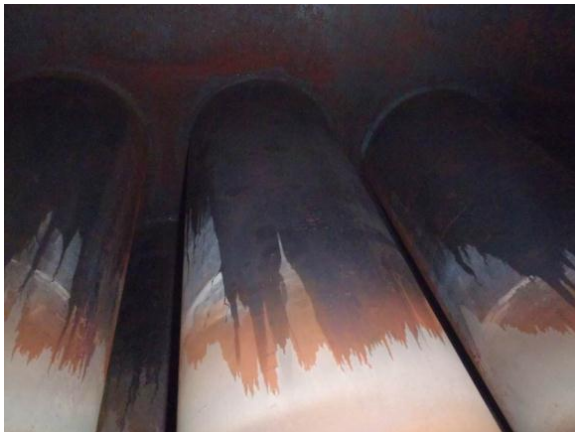
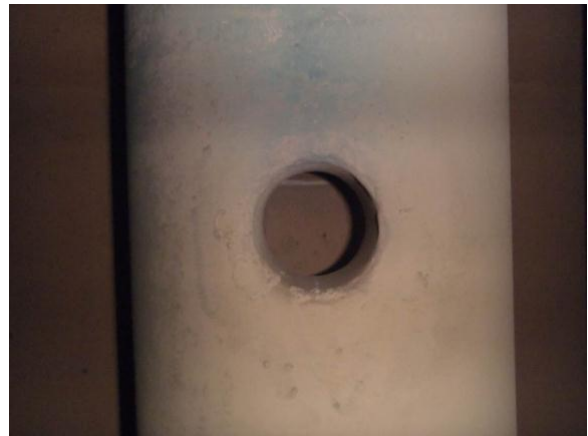
Pic no 24 & 25: Viewing the boiler steam space, pin tubes were found in very good condition. No internal corrosion and deposits found. **End of auxiliary boiler no.1**

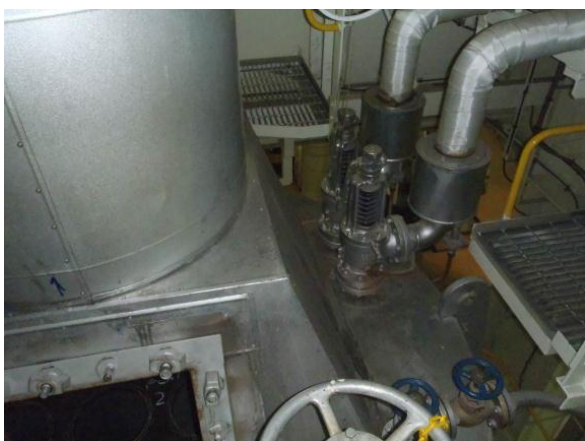
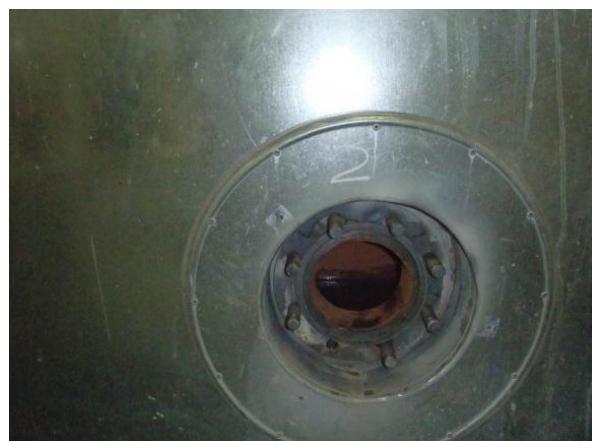
Pic no 3 & 4: Safety valves are in good condition outside and hand hole No.2 was found with minor sign of smoke (gas leak)

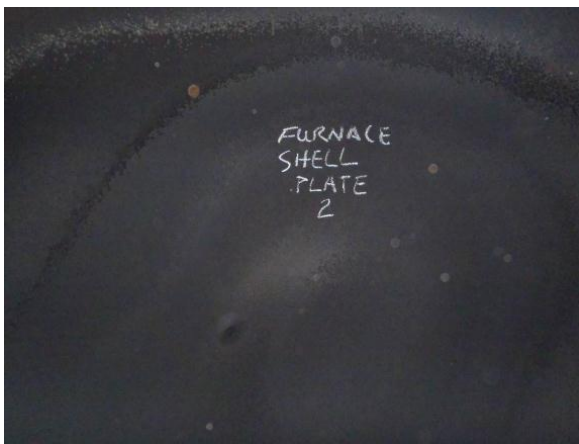
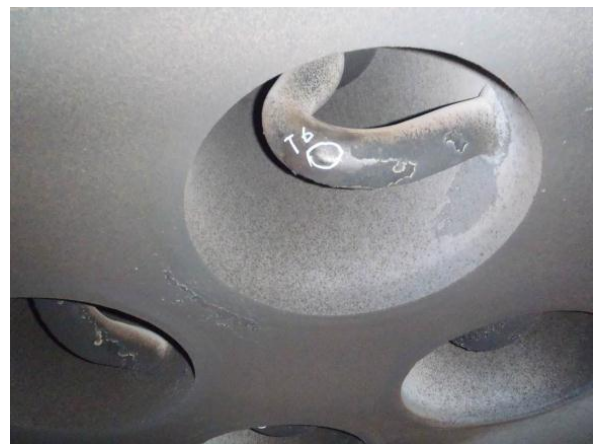
Pic no 6 & 7: Furnace shell plate with no sign deformation or buckle and pin element found to be in good condition, no visible crack or sign of leaked. Soot deposits in acceptable level.

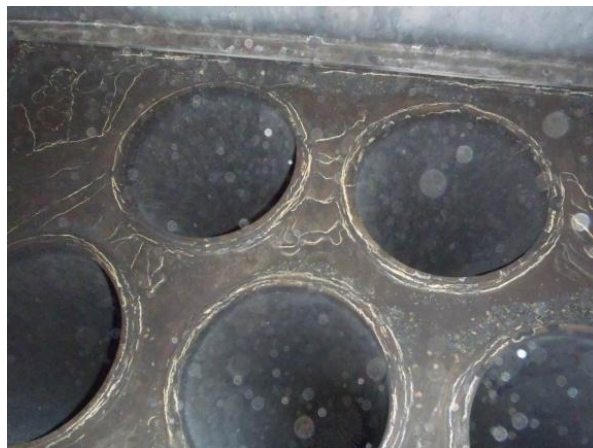
Pic no 8: Looking the pin tubes from the uptake space, all are in good condition including the top tube plate.

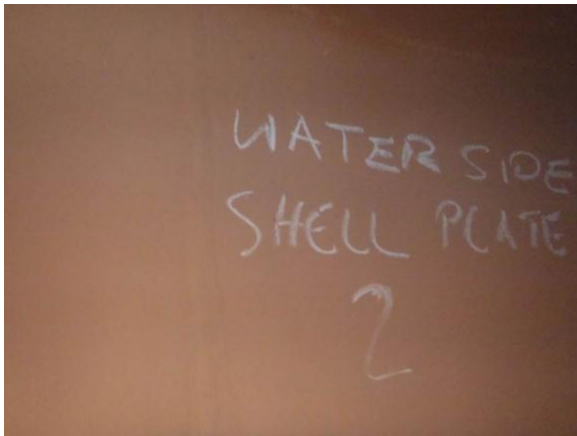
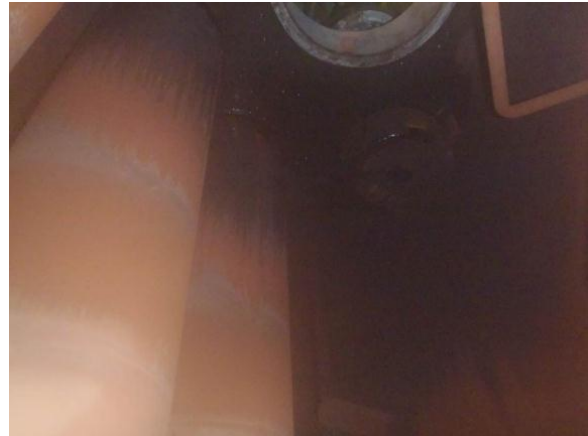
Pic no 9 & 10: Boiler shell plate was found in very good condition and the steam space the top tube plate, pin tubes were also found in good condition.

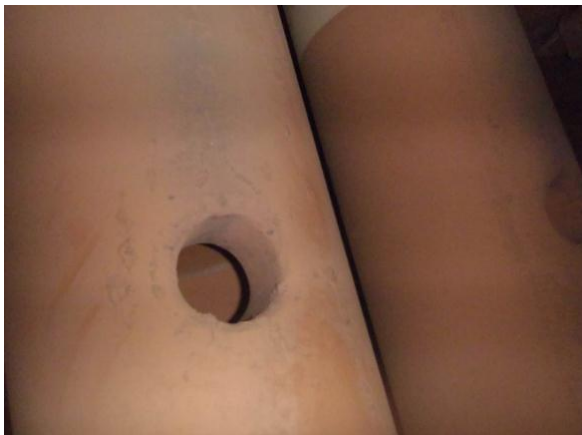
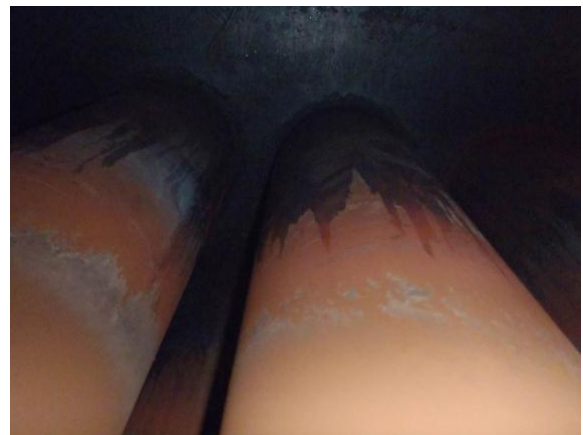
Pic no 11 & 12: Minors scales but not alarming found around the outlet hole some pin tubes

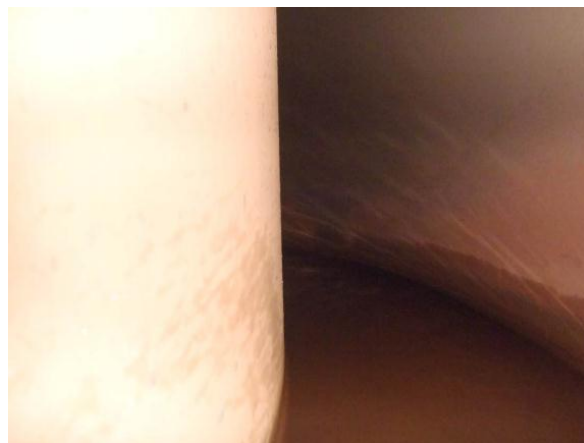
Pic no 13: Showing the bottom ring plate & furnace shell water side. No internal corrosion and negligible loose debris at the bottom

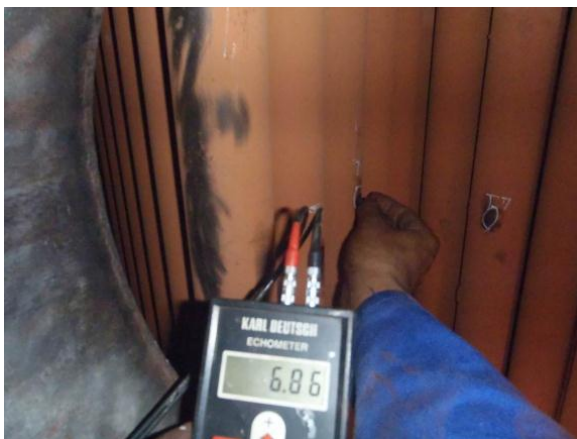
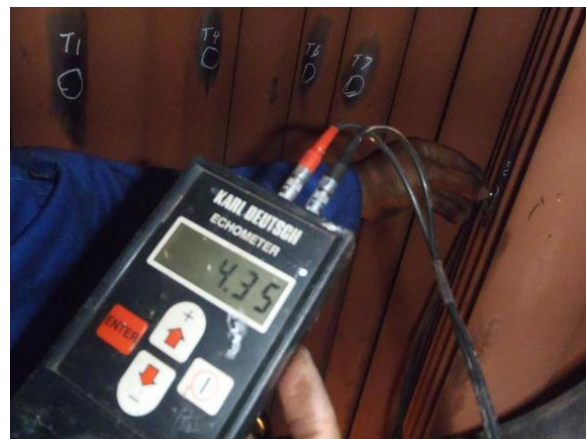
Pic no 1 & 2: UT reading of 6.86 @ the smoke tubes in Economizer No1. And 4.35 @ the smoke tubes in Economizer No 2.

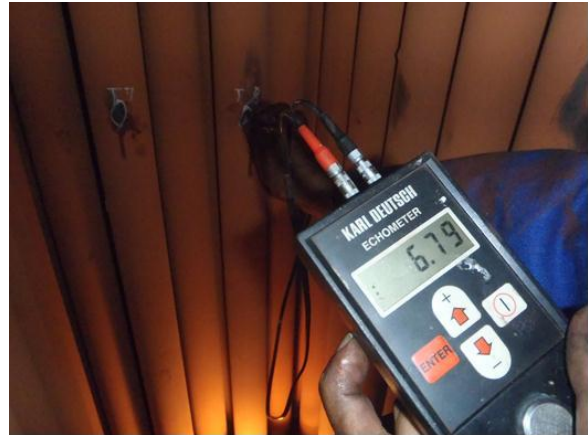
Pic 3 & 4: UT reading of 4.86 @ the smoke tubes in Economizer No 2. And 6.79 @ the smoke tubes in Economizer No 4.

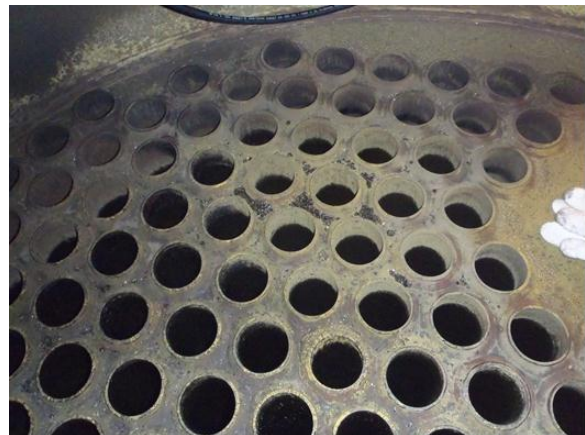
Pic 5 & 6: Top tube plate for economizer 1 with slight amounts of soot.

Soot build up from the economizers gas side can be easily clean by high pressure water washing, however to loosen the soot, it is also advisable to spray (soot/carbon remover) soak for around 1 hour followed by water washing.

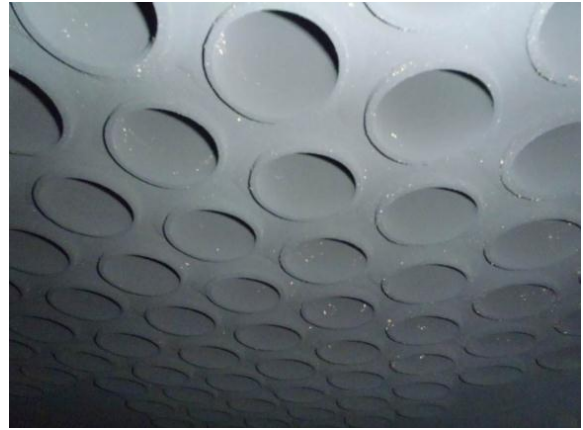
Pic 14 & 15: Top tube plate for economizer 3 with thick amounts of soot.

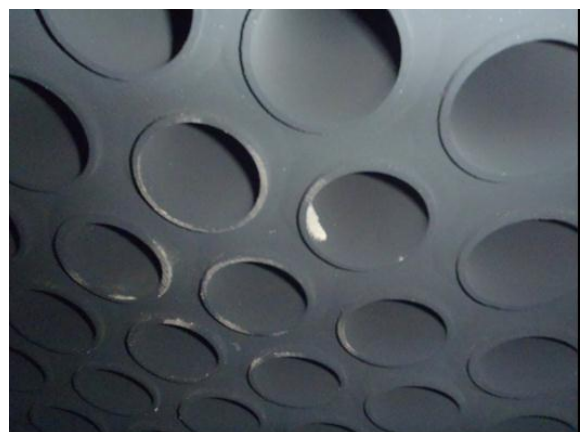
Pic 18 & 19: Top tube plate for economizer 4 with thick amounts of soot

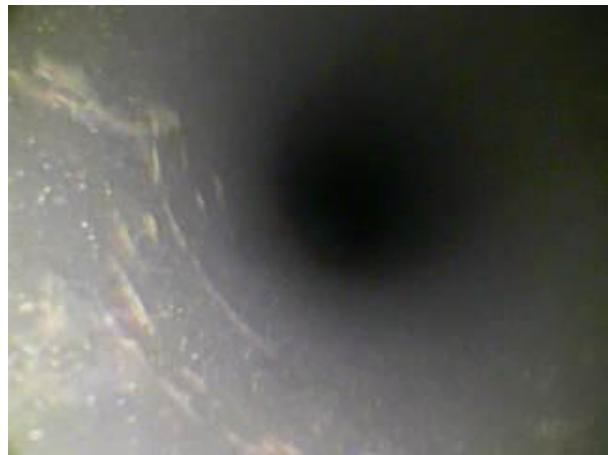
Pic 2: Tube 004- show minor scaling

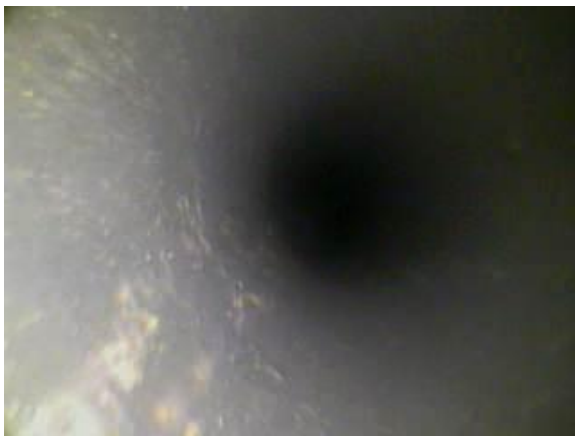
Pic 3: Tube 008- observed minor scaling

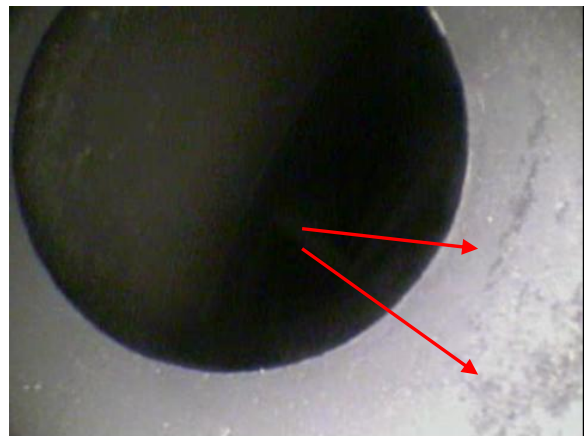
Pic 4: Tube025- small oil deposit
cause unknown

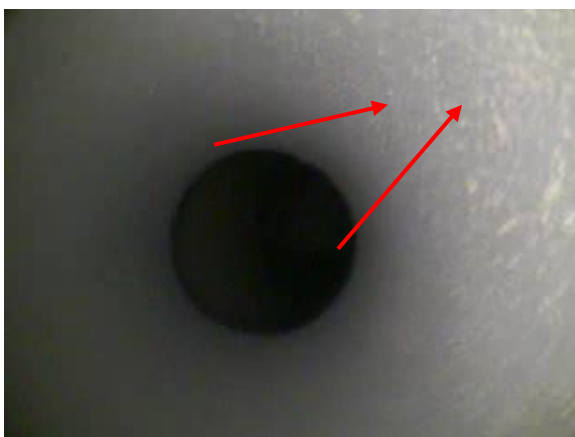
Pic 5: Tube 044- Showing carbon deposits

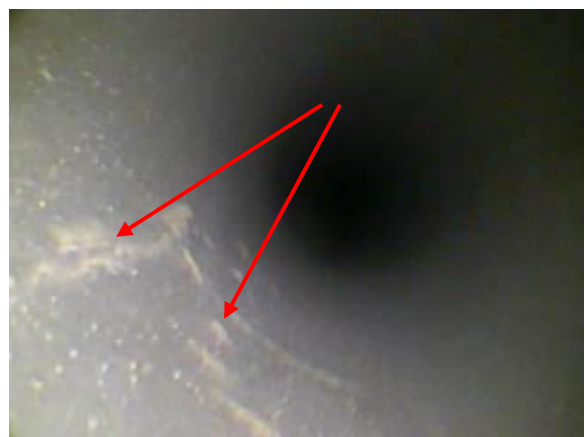
Pic 6: Tube 061-build-up of carbon and
scabs

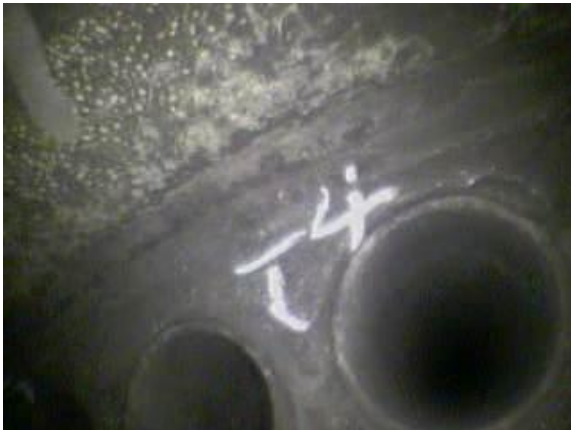
Pic 7: Tube 004- tube plate in acceptable condition

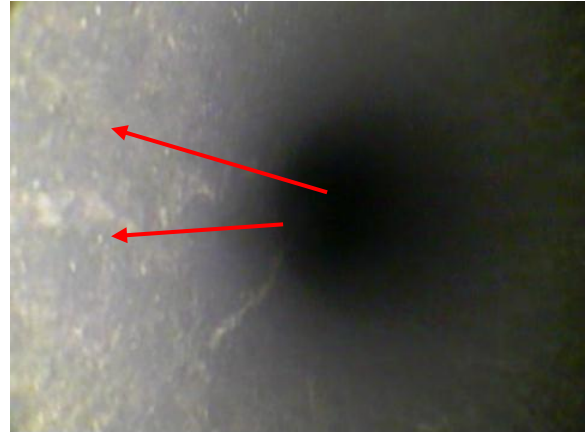
Pic 8: Tube 014- Soot deposits observed.

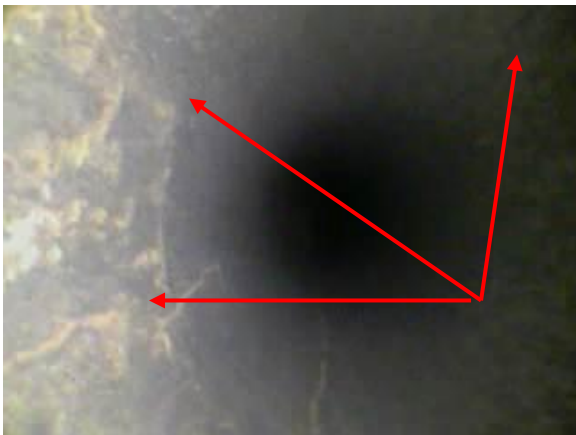
Pic 9: Tube 025- Scale and soot build up

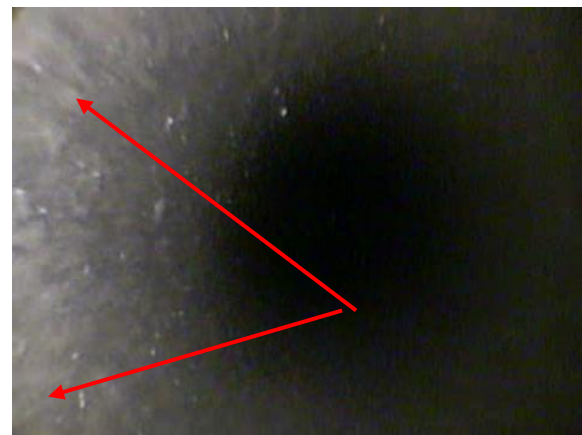
Pic 10: Tube 041- Soot build up observed

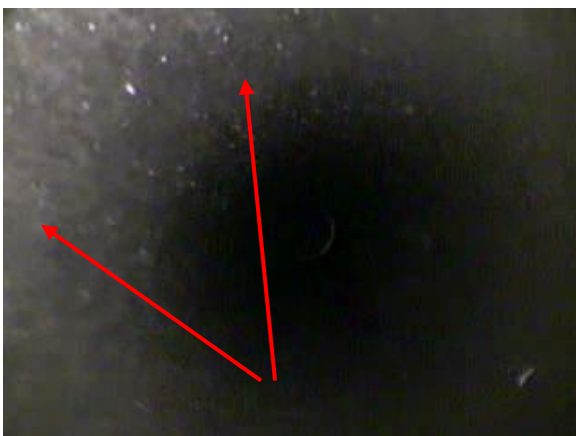
Pic 11: Tube 038- Soot build up con't

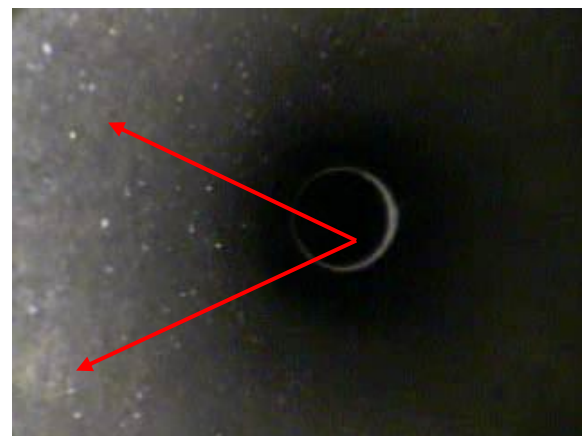
Pic 12: Tube 052- Soot and carbon build up con't

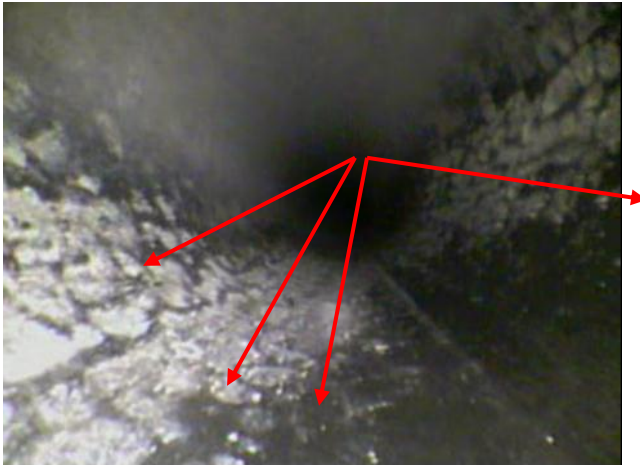
Pic 13: Tube 066- Without any proper chemical analysis, could not determine the origins of the stains and could only conclude that it could be due to bad combustion from the exhaust side

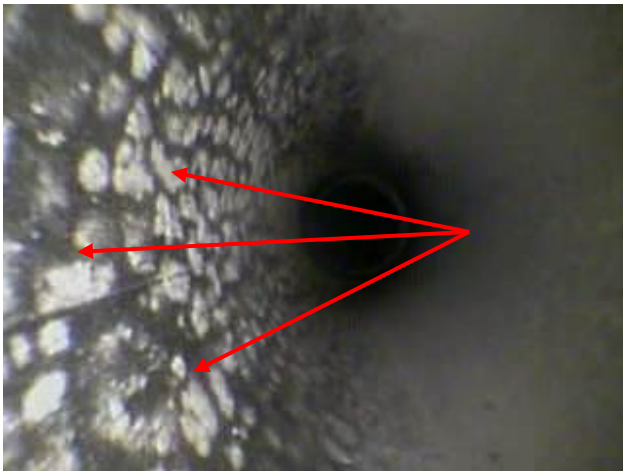
Pic 14: Tube 069- Continuation from the statement as above.

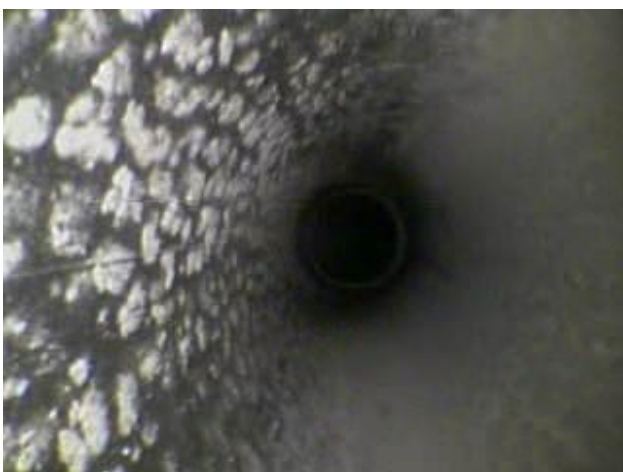
Pic 15: Tube 072- Continuation from the statement as above.

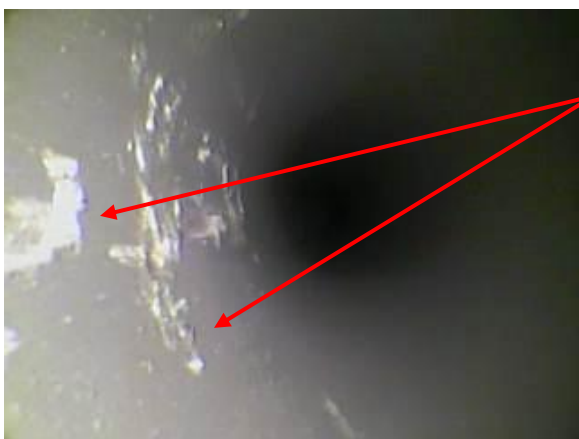
Pic 20: Tube 054- Slight scales noticed

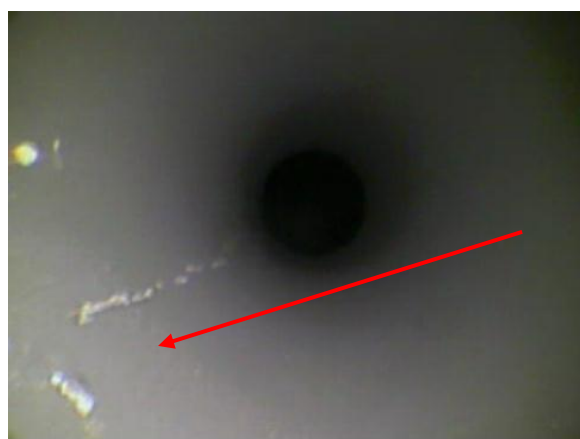
Pic 21: Tube062- Scales & soot observed

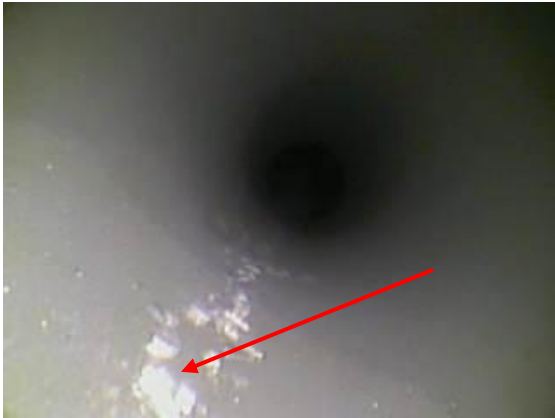
Pic 22: Tube 070- Scaling observed

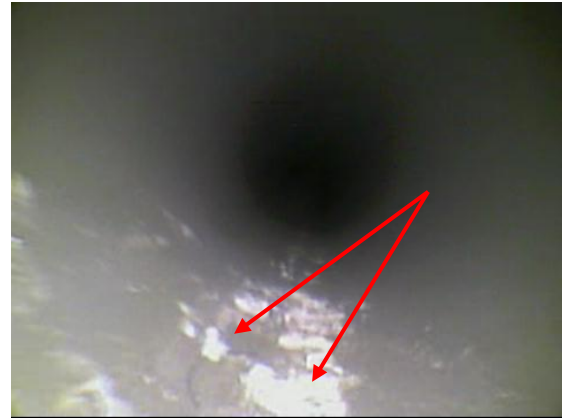
Pic 23: Tube 072- Scaling con't

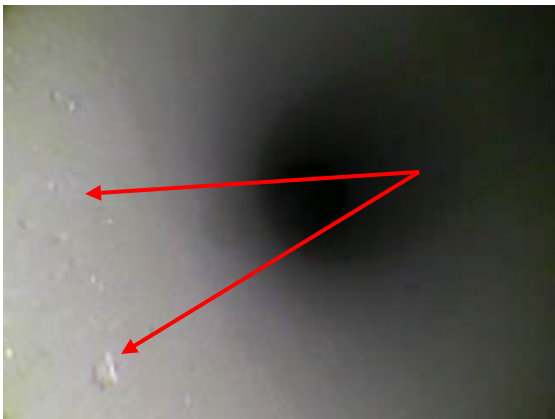
Pic 24: Tubes 007- Slight pitting is observed

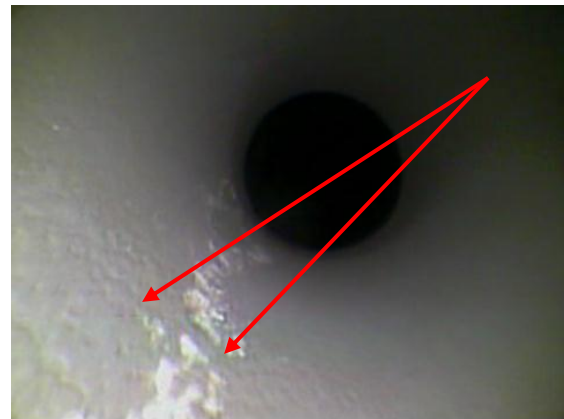
Pic 25: Tubes 015- Bad combusted chemical of unknown origin seen
