Report on Inspection on KANGRIM Aux. Boilers And Economizers

Subject LNG SOYO	Page 1/22
Customer TEEKAY SHIPPING LIMITED	Issued by Kaswadi Hussein
Place of Inspection ANCHORAGE, SINGAPORE	Date of Inspection 01/12/2013

IMC FZC Hamriyah – Sharjah, was requested to attend the vessel “LNG SOYO” which was in, Western Anchorage, Singapore with a view to carry out inspection of the vessel’s Kangrim Aux boiler of 2 Nos. and Kangrim Exhaust Gas Economizers of 4 Nos. The inspection was needed to determine the condition of the existing boiler and exhaust gas system.

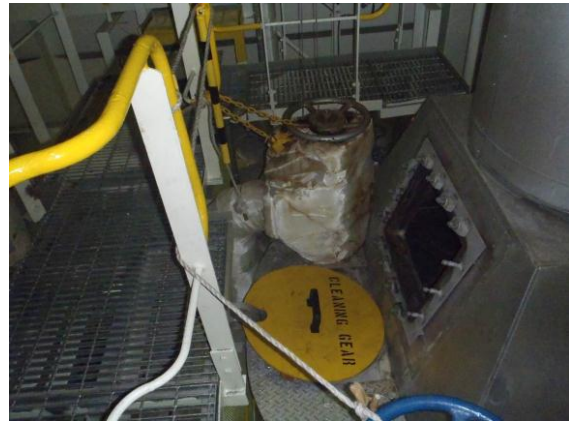
Pic 8: Entrance into the gas uptake and water side

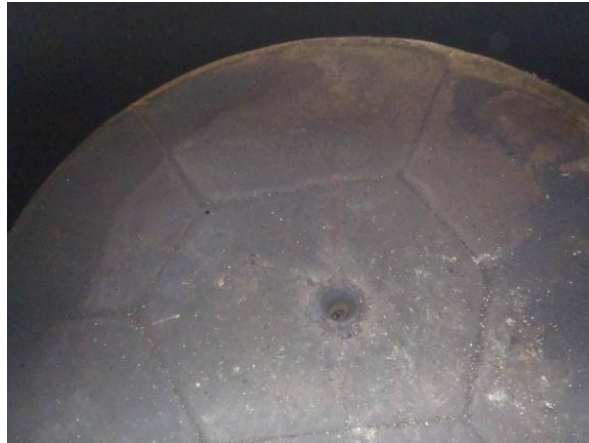
Pic no 5: Furnace entrance and furnace floor refractory

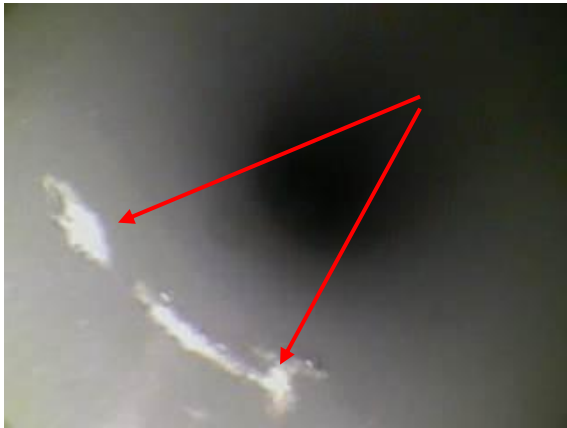
Pic 16: Tube 007- Slight scaling seen

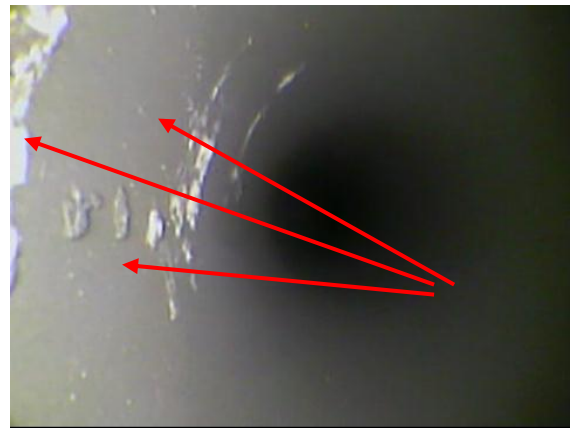
Pic 17: Tube 019- Slight scaling seen

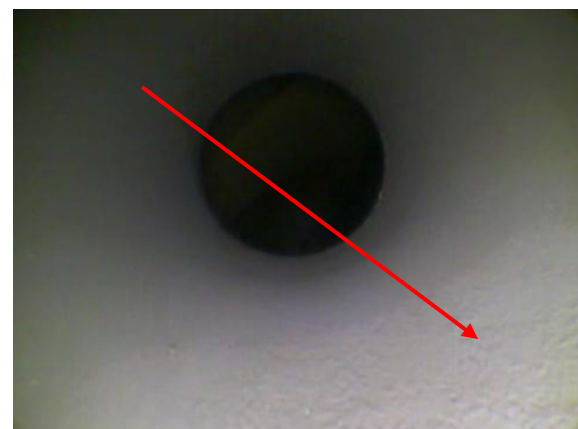
Pic 27: Tube 035- Heavy build-up of soot

Soot build up from the economizers gas side can be easily clean by high pressure water washing, however to loosen the soot, it is also advisable to spray (soot/carbon remover) soak for around 1 hour followed by water washing.

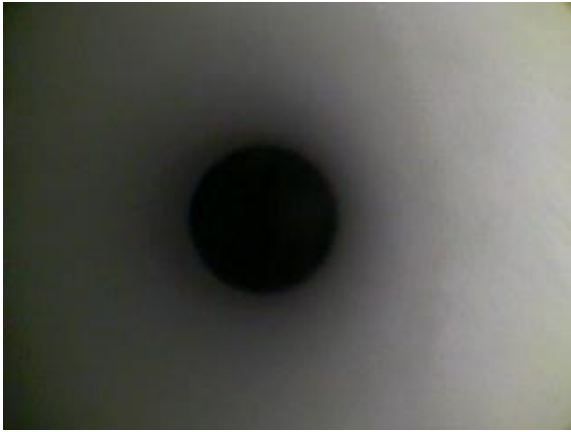
Pic 28: Tube 044- Soot and carbon build up

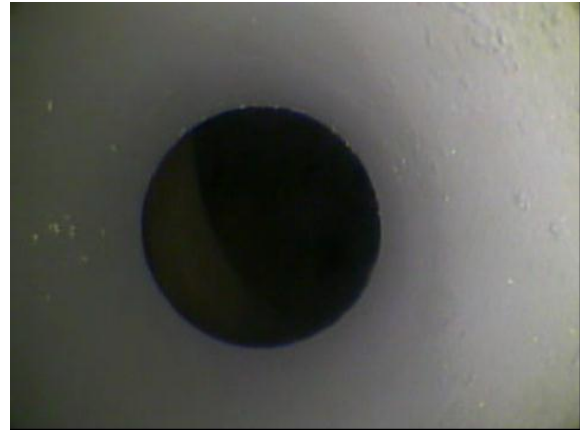
Pic 29: Tube 056- Soot & Carbon build up con't
