Report on Inspection on KANGRIM Aux. Boilers And Economizers

Subject LNG SOYO	Page 1/22
Customer TEEKAY SHIPPING LIMITED	Issued by Kaswadi Hussein
Place of Inspection ANCHORAGE, SINGAPORE	Date of Inspection 01/12/2013

IMC FZC Hamriyah – Sharjah, was requested to attend the vessel “LNG SOYO” which was in, Western Anchorage, Singapore with a view to carry out inspection of the vessel’s Kangrim Aux boiler of 2 Nos. and Kangrim Exhaust Gas Economizers of 4 Nos. The inspection was needed to determine the condition of the existing boiler and exhaust gas system.

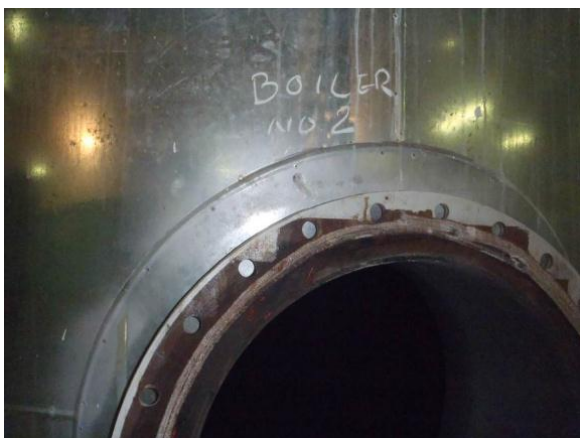
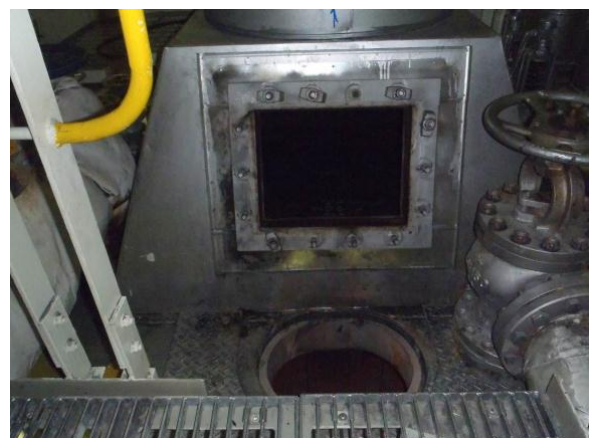
Pic no 1 & 2 Access to the furnace room and uptake space + manhole on top going to water space are open for entry.

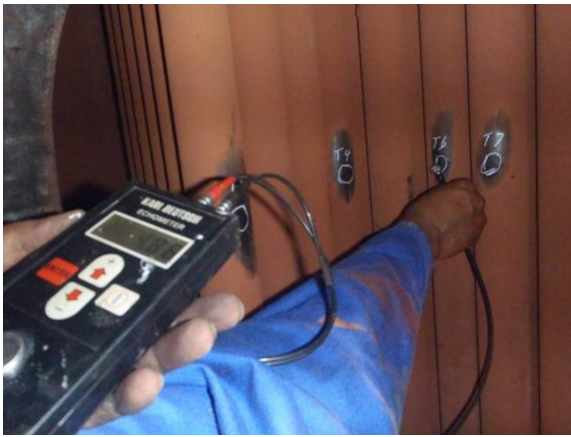
Pic 3 & 4: UT reading of 4.86 @ the smoke tubes in Economizer No 2. And 6.79 @ the smoke tubes in Economizer No 4.

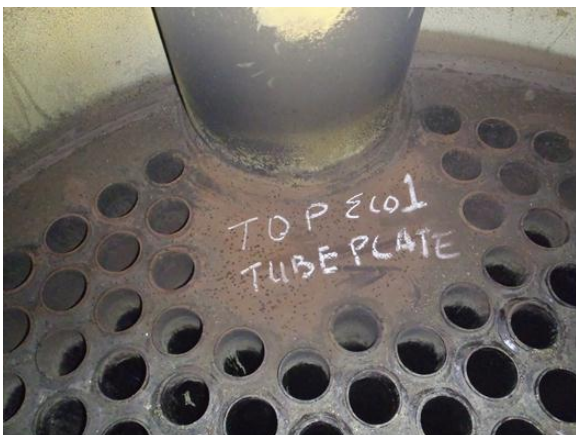
Pic 5 & 6: Top tube plate for economizer 1 with slight amounts of soot.

Soot build up from the economizers gas side can be easily clean by high pressure water washing, however to loosen the soot, it is also advisable to spray (soot/carbon remover) soak for around 1 hour followed by water washing.

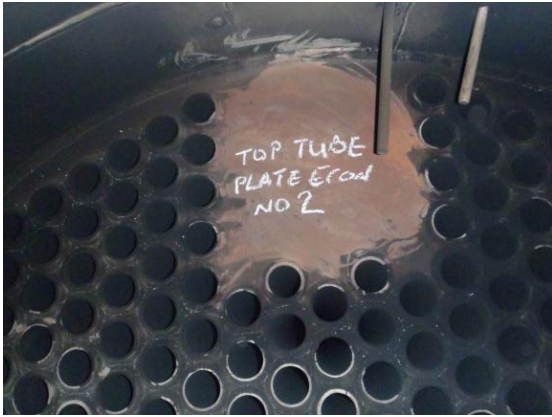
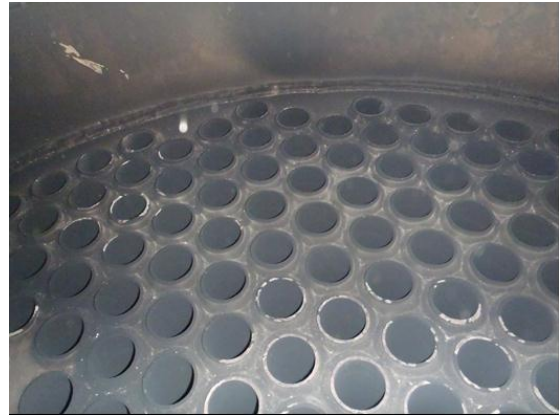
Pic 8 & 9: Top tube plate for economizer 2 with thick amounts of soot.

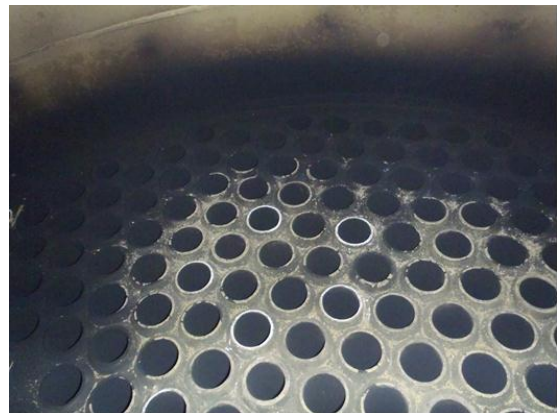
Pic 12 & 13: Top tube plate for economizer 3 with thick amounts of soot.

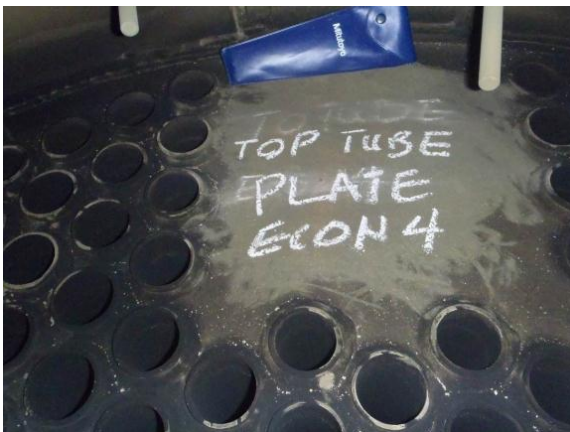
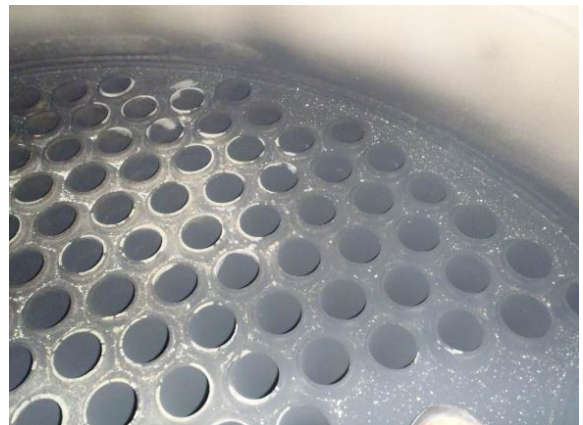
Pic 16 & 17: Top tube plate for economizer 4 with thick amounts of soot.

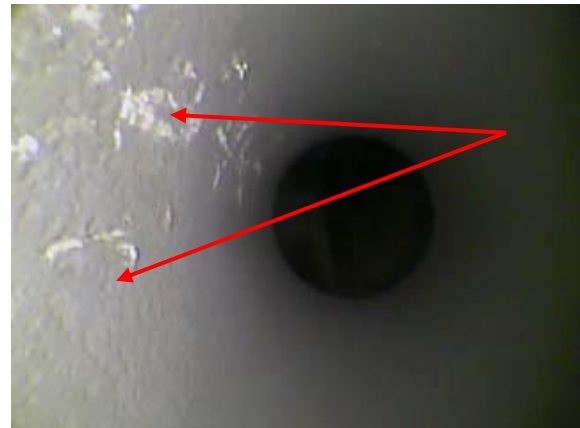
Pic 19: Tube044- Small amounts of scaling

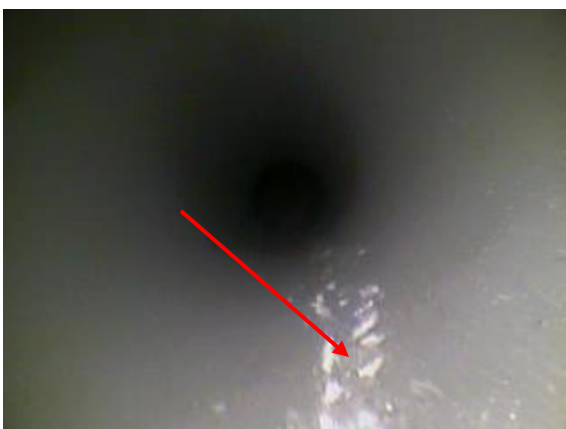
Pic 26: Tube 022- Continued from pic above

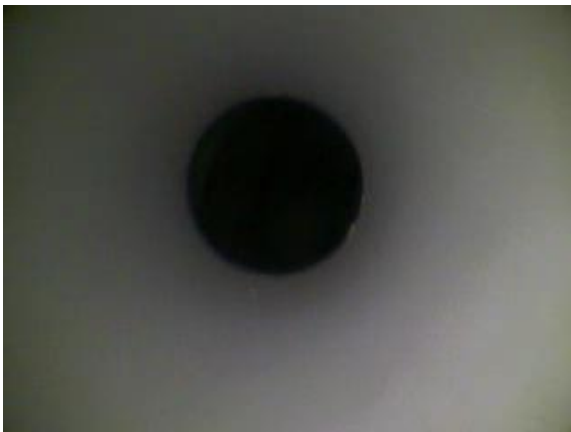
Pic 31: Tube 026- Carbon Build up
